Re.: **Inspection Report (4 of 6) for The Towers**

**THE TOWERS**  
2366 EAST MALL DRIVE  
FORT MYERS, FL 33912

*Crowther Roof Check Maintenance Program-Inspection Report*

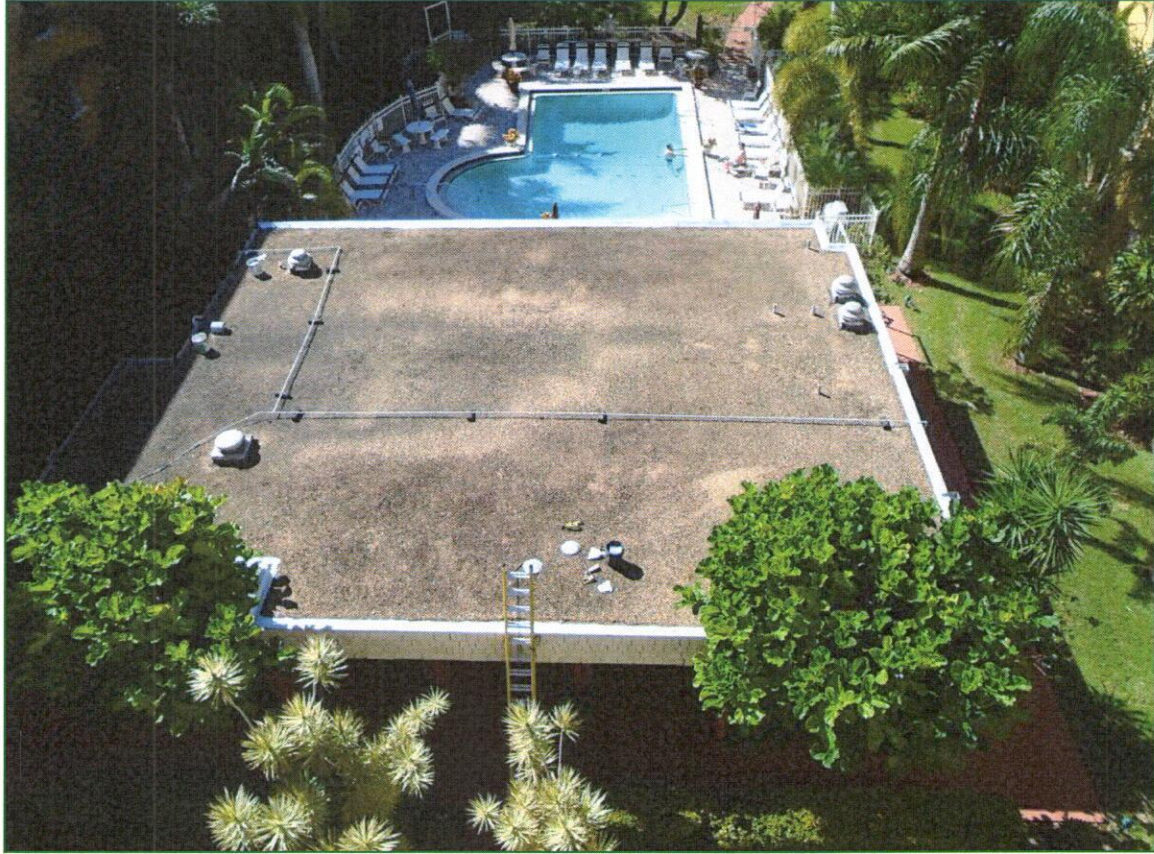
**EXHIBIT #: 2**

Main Roof Overview

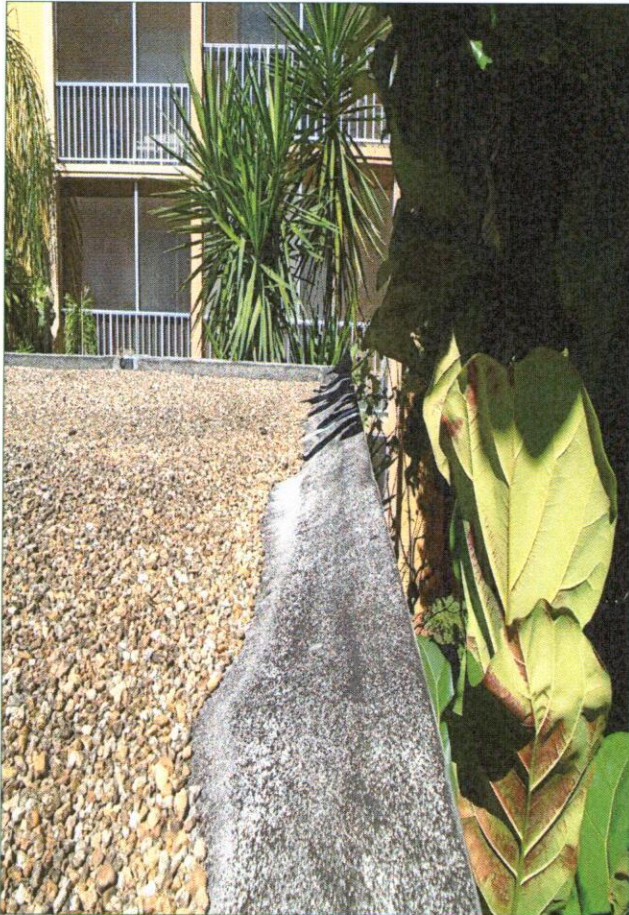
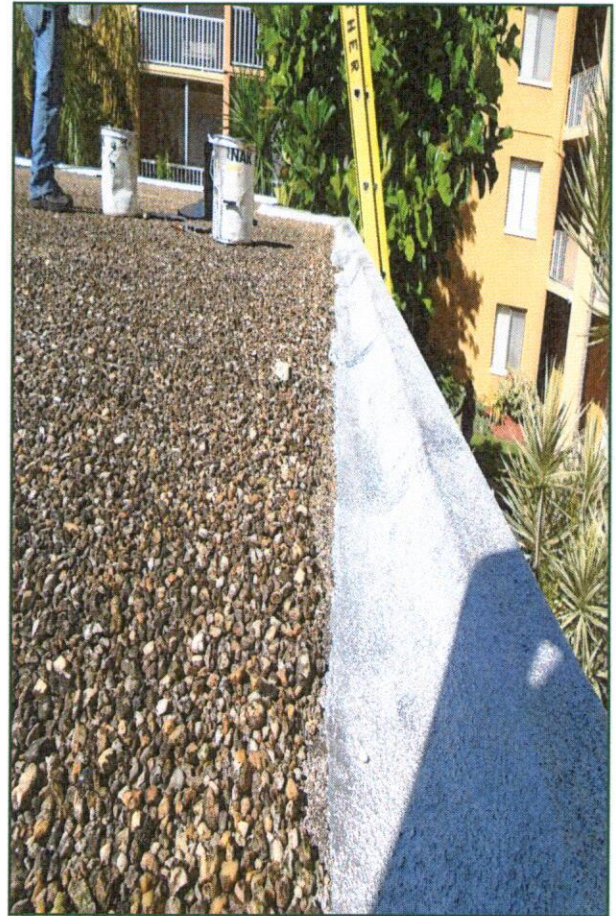
**EXHIBIT #: 3**

- Found an area of deteriorated base flashing at the perimeter edge

Found areas of deteriorated  
base flashings

- Coated the base flashing with aluminum coating

Coated the base flashings with  
aluminum coating

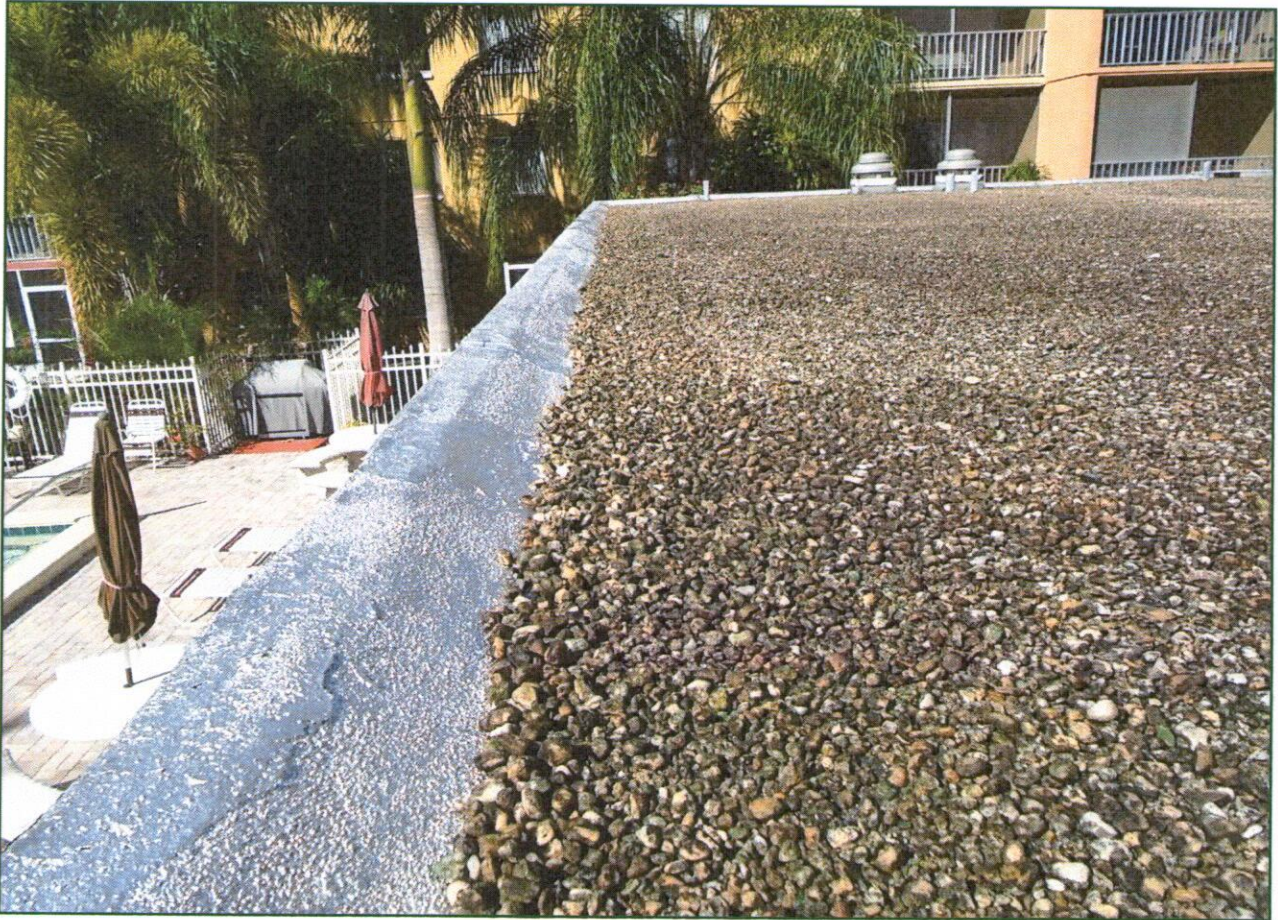
**EXHIBIT #: 4**

Found areas of deteriorated  
base flashings

Coated the base flashings with  
aluminum coating

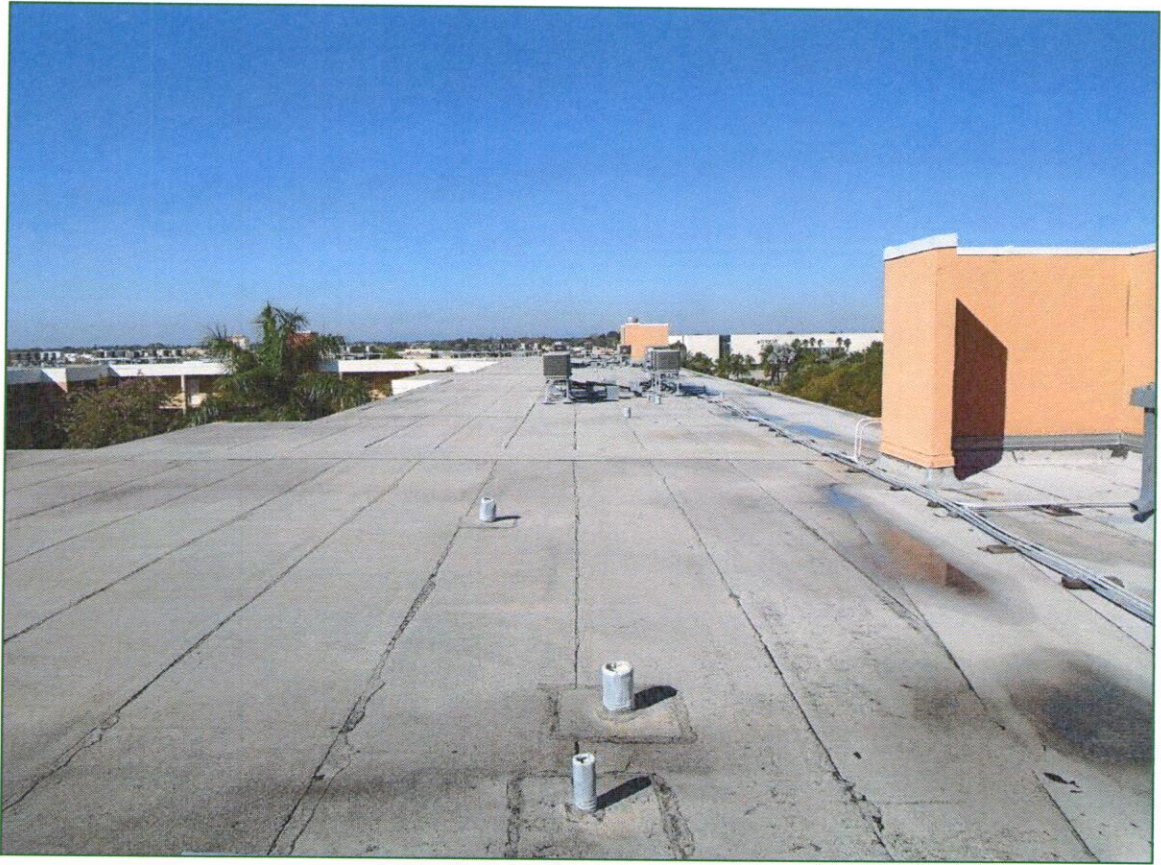
**EXHIBIT #: 5**

Main Roof Overview

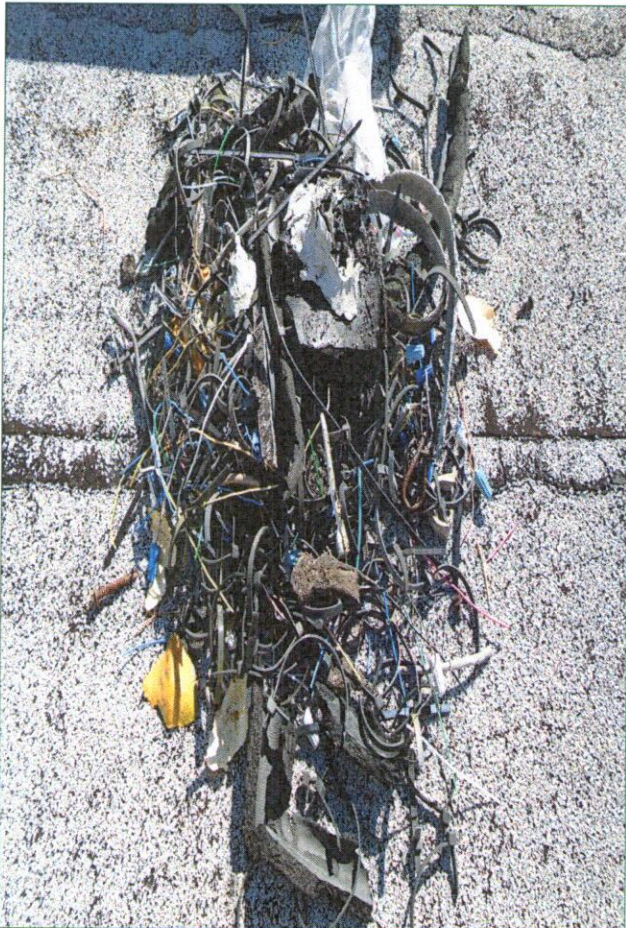
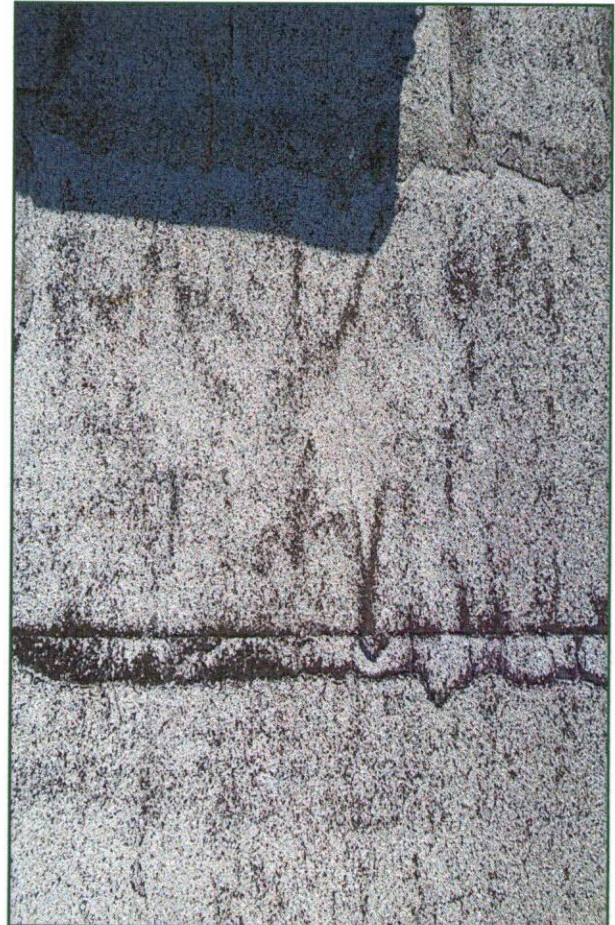
**EXHIBIT #: 6**

Found debris on the roof surface

Removed the debris from the  
roof surface

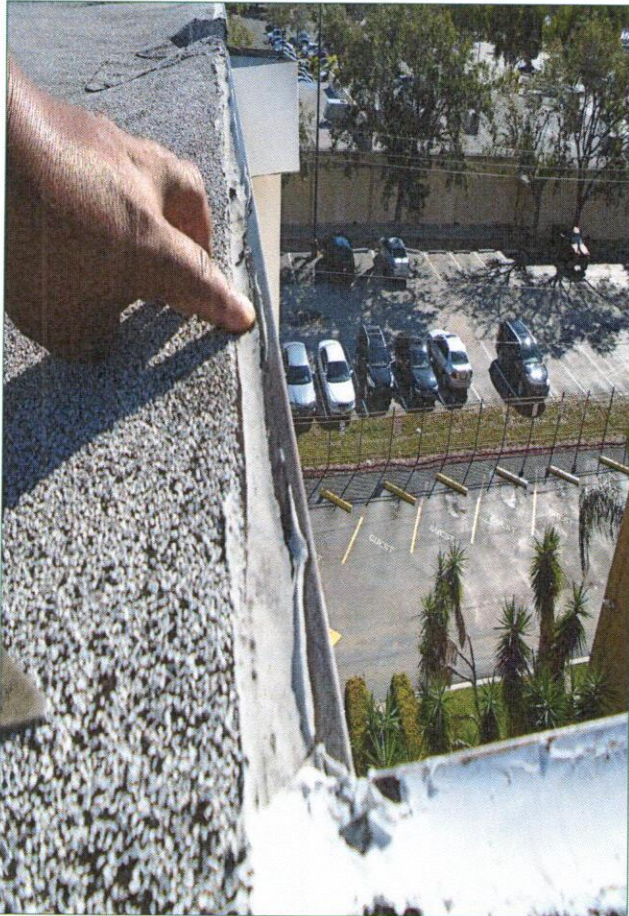
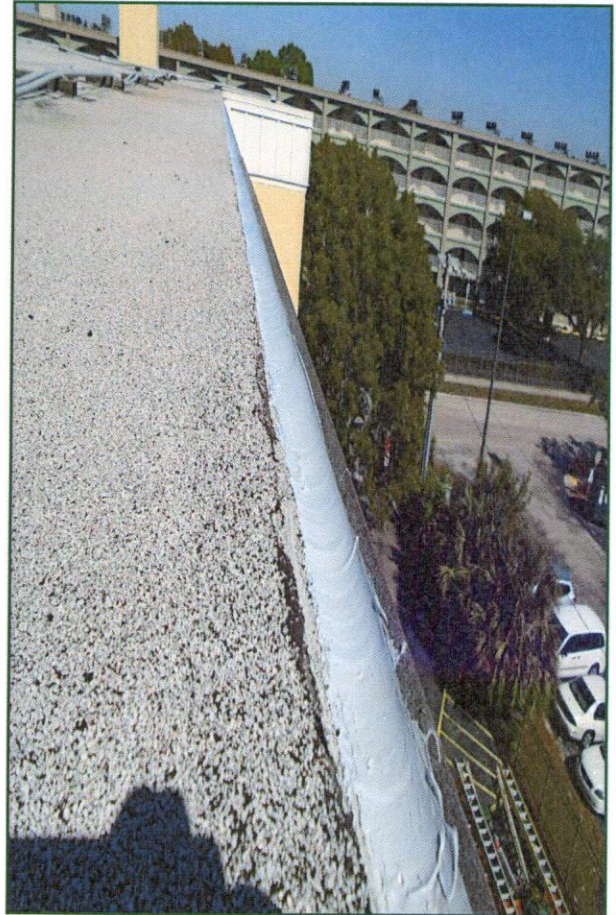
**EXHIBIT #: 8**

Identified loose sealant at the gravel stop

Sealed the gravel stop metal  
with sealant

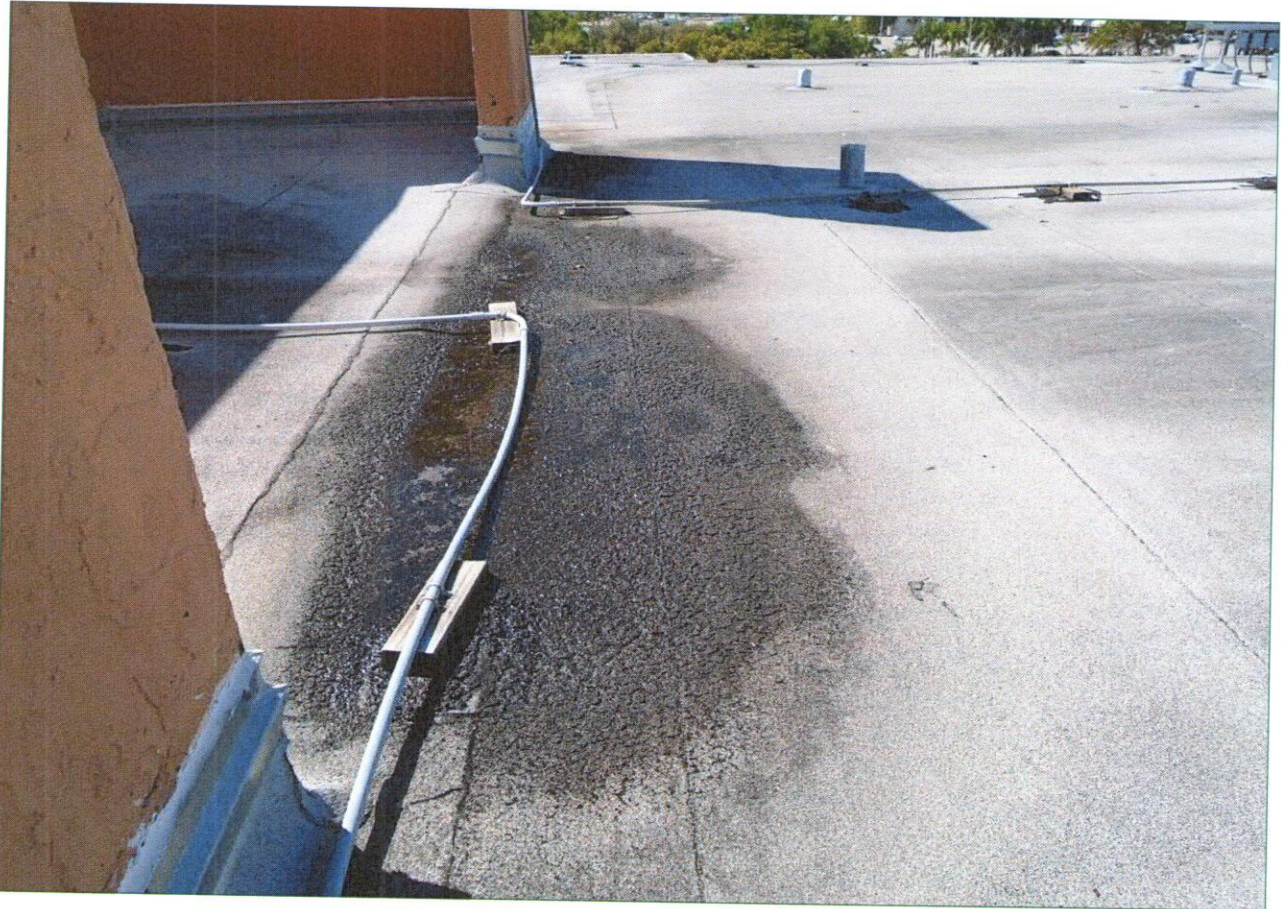
**EXHIBIT #: 9**

Found an area of ponding water on the roof surface

- Will monitor the area where water is ponding.

Will monitor the area where the water is ponding
